**Air Branch Inspection Report
Unannounced Full Compliance Evaluation
Hamm Sanitary Landfill**

16984 3rd Street
Lawrence, Kansas 66044
FRS# 110007364495

March 29, 2022

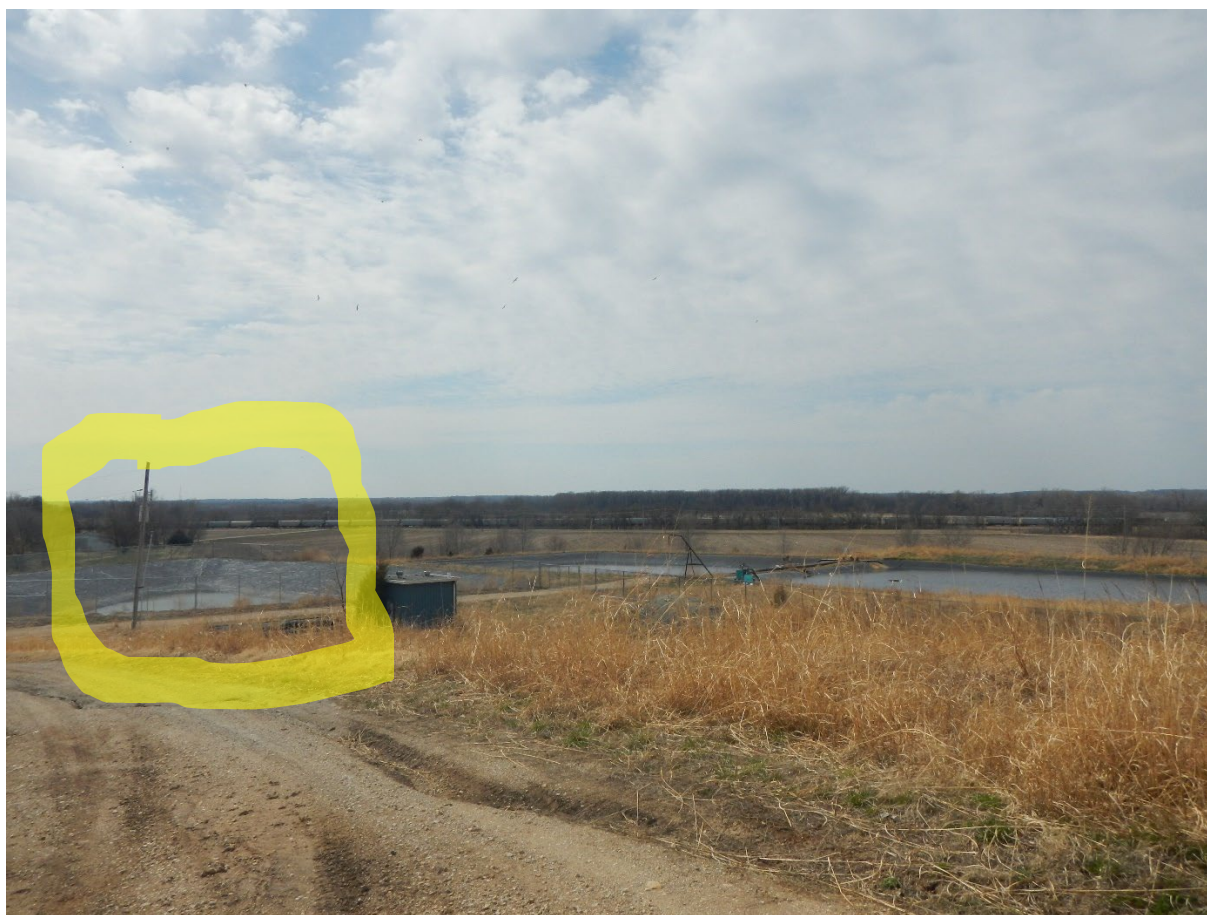
Figure 1. Three leachate ponds. Newly installed pond to the left

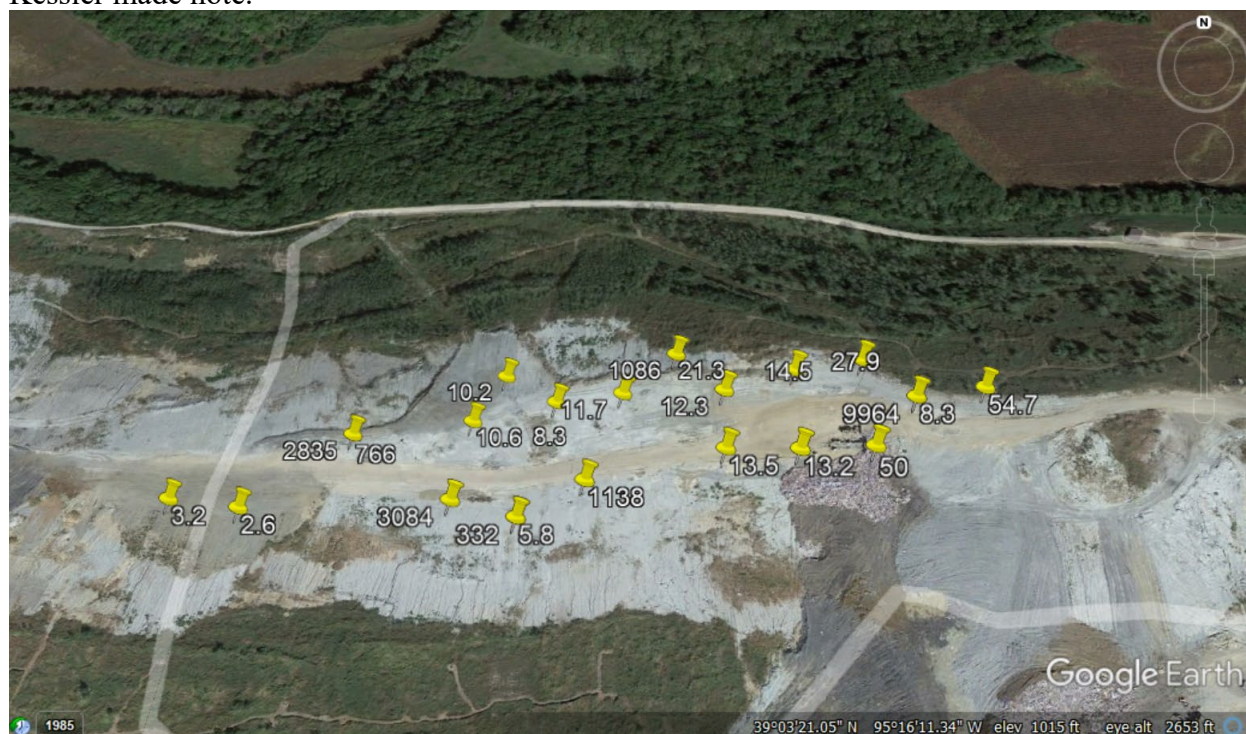
seconds. Ms. Kessler and I walked around the landfill and noted 7 areas where methane emissions exceeded the 500 parts per million (ppm) threshold (Table 5). We did not collect TVA readings around active cell 112 because there were trucks operating and dumping waste. Around 1:58 pm, while we were conducting the surface emission monitoring, the flare began operating and Mr. Meyers noted that a horizontal gas line well was cracked and that the system went down.² He said that may contribute to the higher methane values shown on the TVA and Ms. Kessler made note.

Figure 2. Areas surveyed with TVA and respective methane values in parts per million.

The inspection team conducted field measurements via Method 21, as required by 40 CFR Part 62, Subpart OOO. Figure 2 shows the areas on the landfill that were measured throughout the inspection. **Table 5** summarizes field measurements that were above the 500 ppm threshold for methane.
